# Gates Mills Fire Department

## A HISTORY OF GAS WELL INCIDENTS IN GATES MILLS

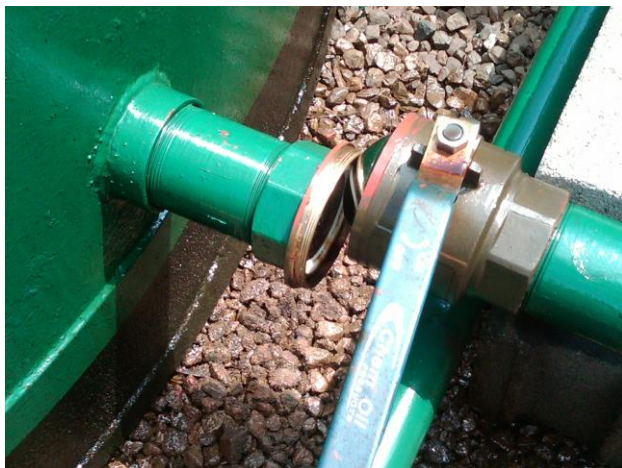
The investigation continued and the Ohio EPA and Ohio Department of Natural Resources were contacted. At 11:45 on 6-20-2010 the source of the leak was identified by Chief Robinson and a representative of the Gas/Oil industry, as the Gas Well located at 1959 Som Center Road operated by Pursie E. Pipes Company. The valve attached to the Oil tank had separated which allowed 1000 gallons (ODNR estimate) of Crude Oil to escape into the containment dike. Reports indicated that the facility had been checked on June 18, 2010 by a representative of Pursie E. Pipes Company and no leaks were present at that time.

At a point near the Northwest corner of the dike the Oil escaped the containment area and entered a small drainage ditch that runs across the back of the properties along Som Center Road. This drainage ditch then runs between the homes on Gates Mills Blvd. and then goes below ground into the storm sewer. From that point the flow remained underground in the storm sewer a distance of more than one mile until it resurfaces at the Teardrop area.

On 6-21-2010 at 16:00 all of the contaminated soil at the Tank Battery location had been removed and replaced with new soil and “blue” clay. This was crucial so that the forecasted rain did not re-contaminate the areas that had been cleaned.

This effort is will continue until the entire area has been returned to its previous condition under the supervision of the Ohio EPA. The absorbent booms and pads will remain in selected locations for approximately one week and will be checked and replaced if needed on a continual basis.
